TECHNICAL REPORT TR-NAVFAC-EXWC-EX-1601 APRIL 2016

REMOTE COLLABORATIVE 3D PRINTING - PROCESS INVESTIGATION

Cody M. Reese, PE

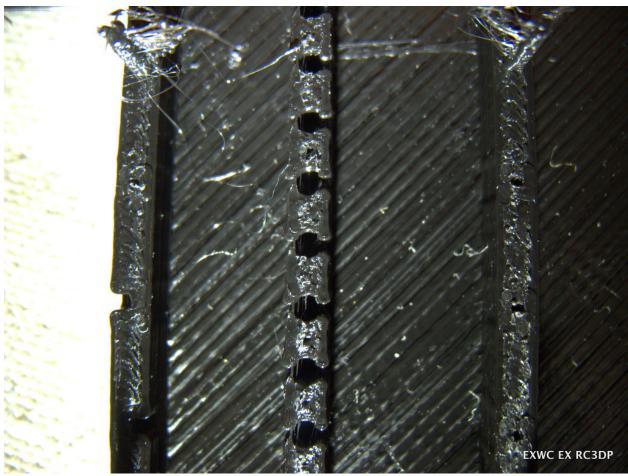
Figure 6: This underside close-up of the first pier print illustrates the inability of an FDM printer to resolve features smaller than the diameter of the extruded filament

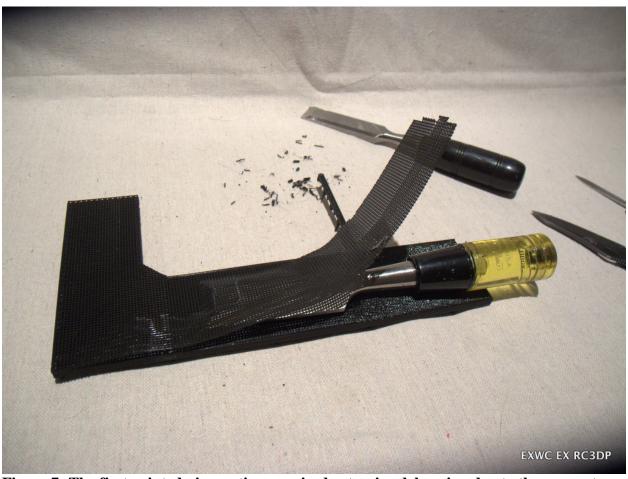
Figure 7: The first printed pier section required extensive deburring due to the support layer printed beneath the entire part.

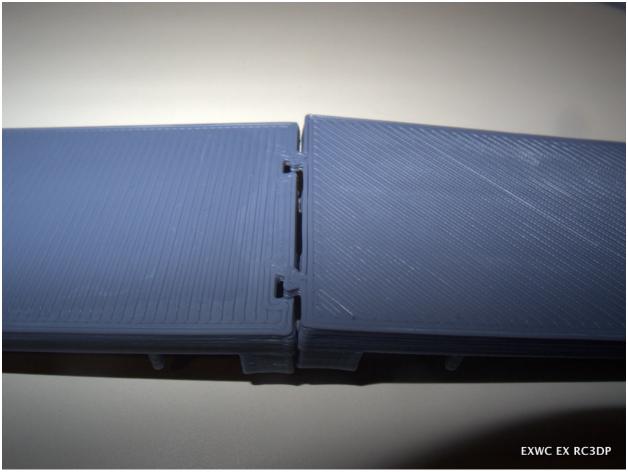
Figure 19: The warping caused by residual thermal stress, and dimensional overruns did not allow mating of the model sections without manual rework.

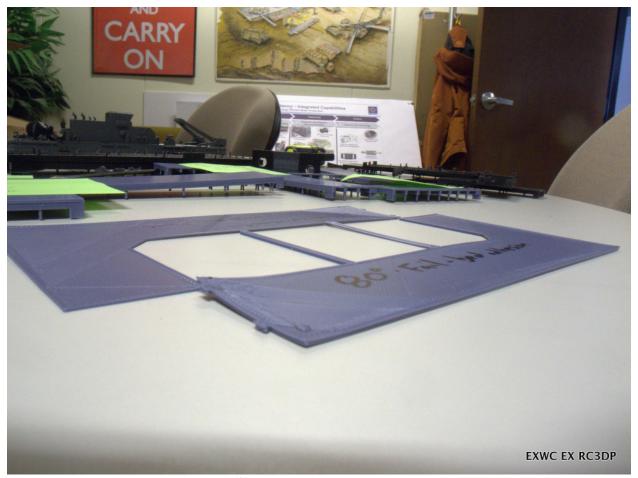
Figure 21: Attempts to print HIPS parts at reduced bed temperatures resulted in adhesion failures.

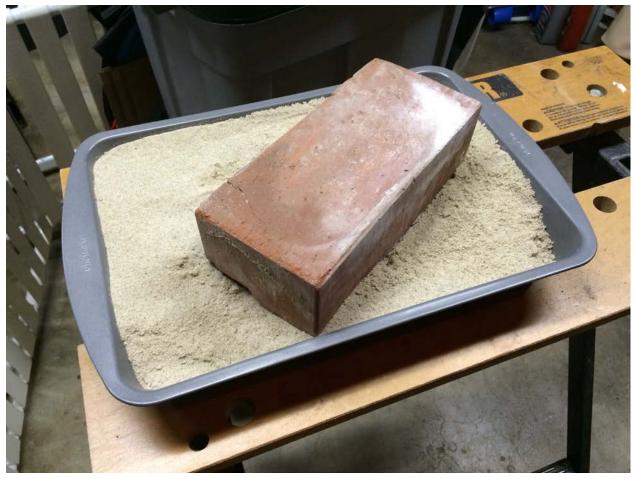
Figure 22: Warped parts were annealed under a weight in a bed of sand to control heat transfer rate and ensure uniform cooling.

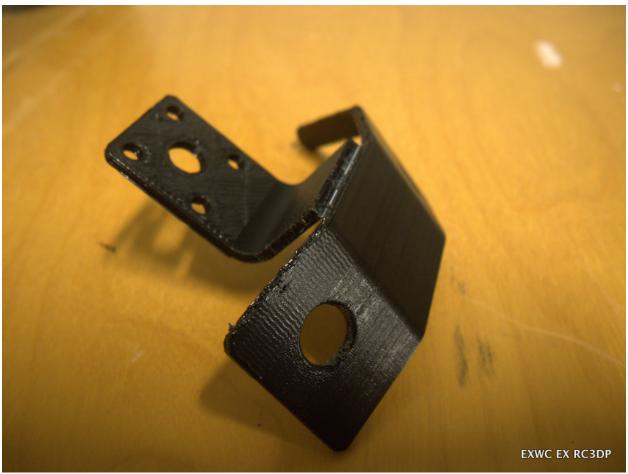
Figure 29: The fire extinguisher bracket broke along a layer interface at a high-stress area, in spite of delicate handling.

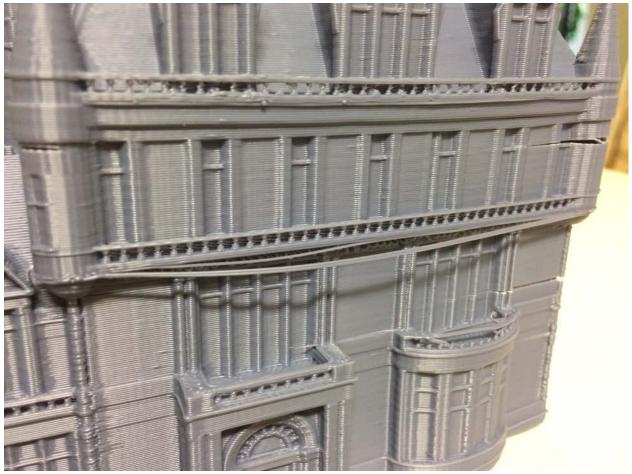
Figure 37: This surface detail of Vanderbilt mansion print shows unsuccessful elements of the print due to lack of support material.

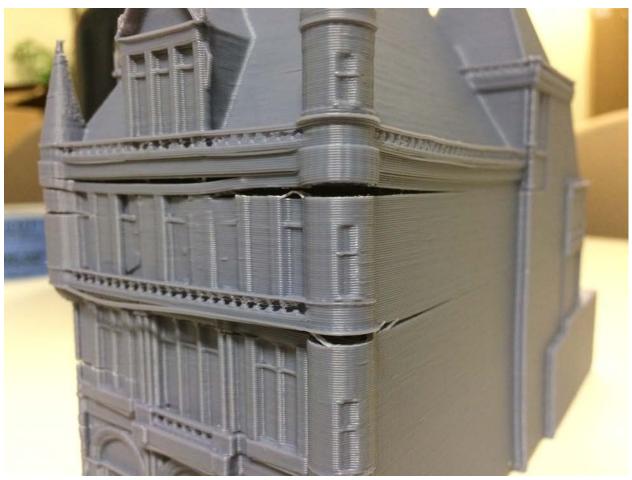
Figure 38: The surface detail of Vanderbilt mansion shows cracking and delamination, likely as a result of thermal stresses and poor layer adhesion at fast print speeds without optimized or adjusted temperature parameters.

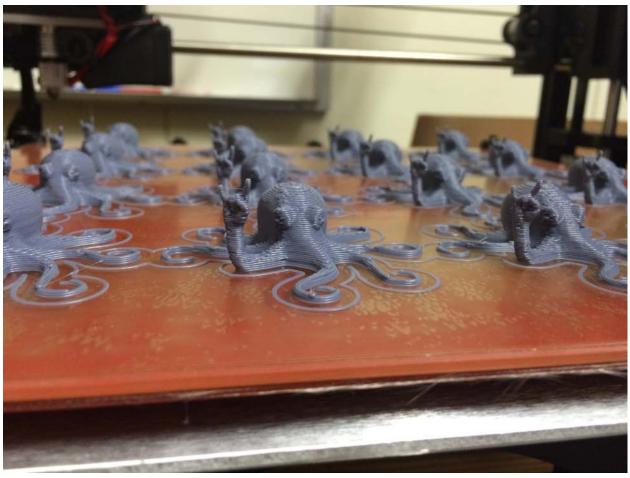
resulting in unique part appearances. The overall shape of parts is identical for all intents and purposes, but it is clear that the start/stop "seam" is in a different place on each part resulting in a difference of appearance as shown in figure 51. Additionally, each part exhibited different bed adhesion issues and regions as shown in figure 50. Nearly all of the parts printed in the array showed some level of bed adhesion failure at the corners, but the extent and area on each part was slightly different. None of the bed adhesion issues resulted in print failure.

Figure 51: The batch print operation of the "Rocktopus" model revealed that each instance showed minor variation based on extrusion start/stop points.
